MINISTRY OF PARKS

**NIMPKISH RIVER
ECOLOGICAL RESERVE
EROSION PROTECTION PLAN**

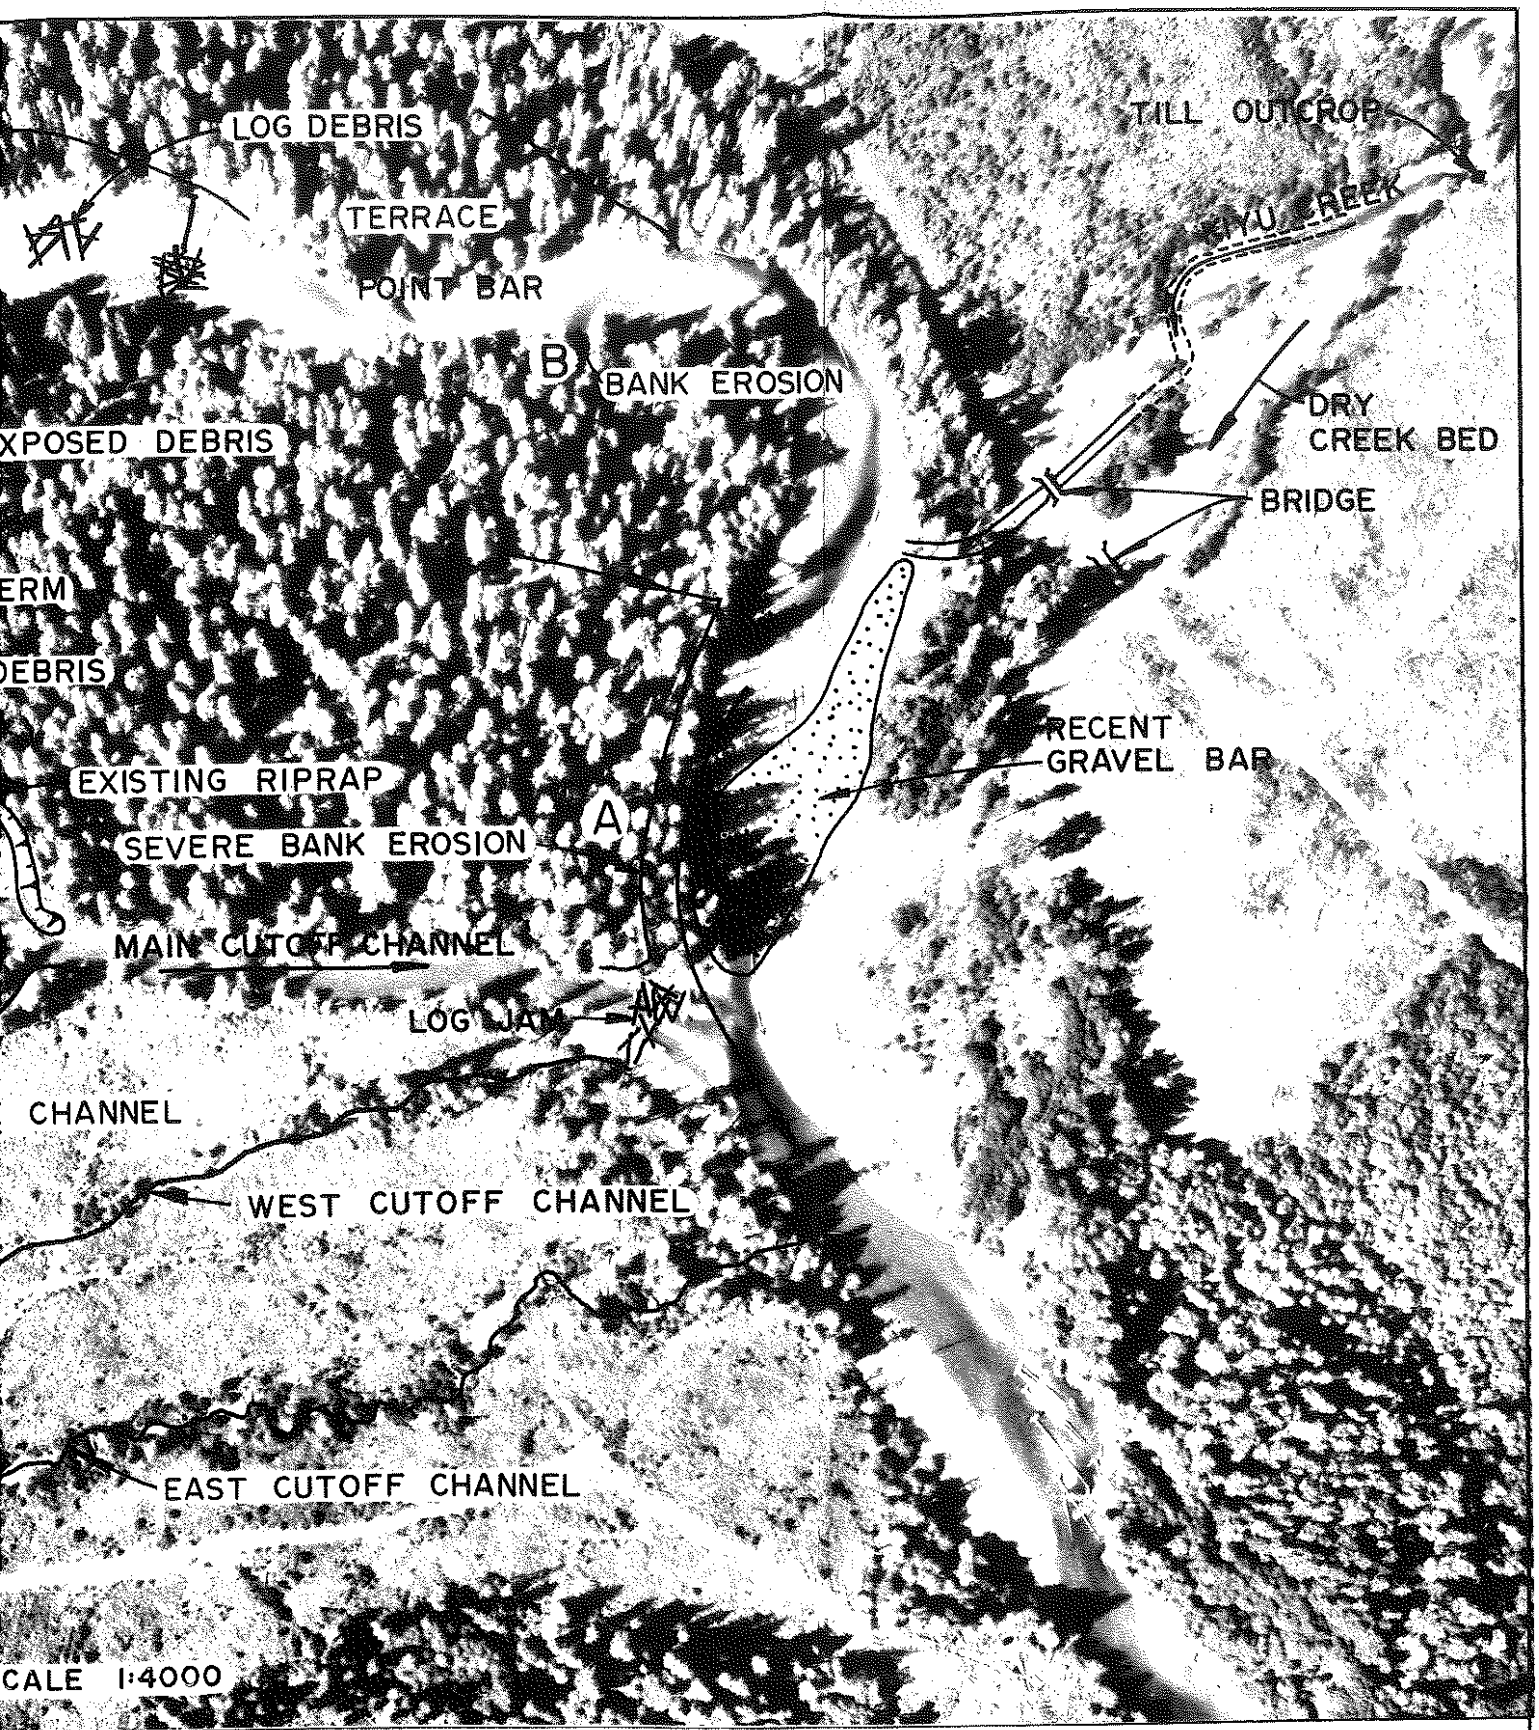
FIG.
2

The areas of present erosion around the perimeter of the island, Figure 2, are well documented in the Ministry's files and can be referred to as:

- A. the east half of the north side opposite Kiyu Creek (erosion along the north side),
- B. the north half of the west side (erosion along the west side), and
- C. the south east corner and part of the south side (the southeast corner). This area has been repaired and is not presently eroding.
