**Gooding
Hydrology**

**SUTTON CREEK
Investigation of Flood Risks in Honeymoon Bay
With
Flood Mitigation Recommendations**

**For
The Provincial Emergency Program
Victoria, B.C.**

July 2007

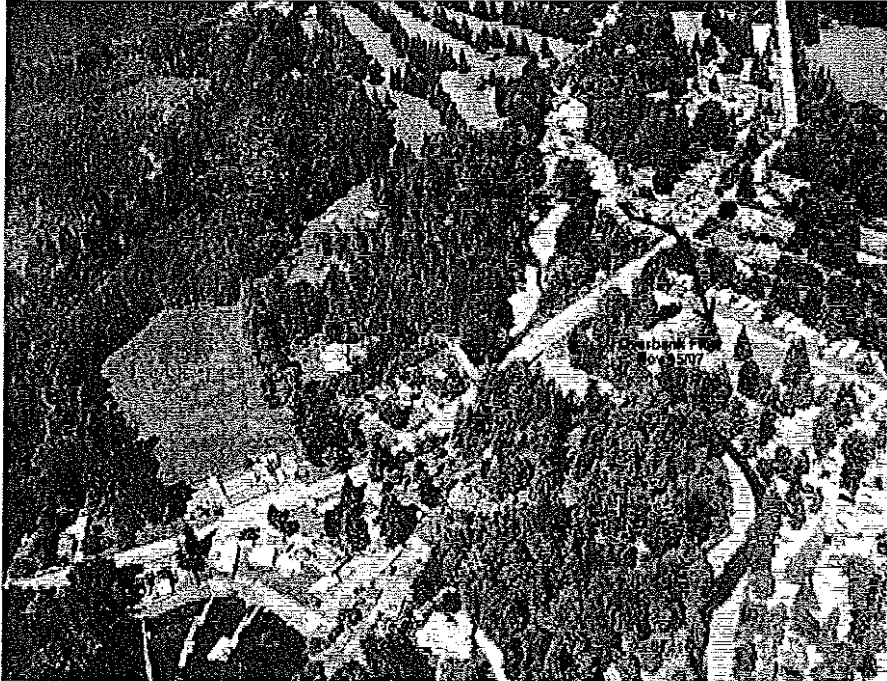
Photo 2a

A high risk location is the eroding bend behind the three residences which were inundated this last year, with flows then going across the highway. Unless some flood damage mitigation works are done, there is a high likelihood of overbank flow, and flood damage, at a Mean Annual Flood level, with occasional but less frequent cross highway

South Shore Road highway bridge, trailer park to lower right, golf course upper center.
Overbank flow path through residences, across highway, and into trailer park marked.

1. For flood mitigation for the inundated residences, and to reduce the likelihood of cross highway flow, the large gravel accumulation across nearly the entire channel width upstream of where the channel splits, and some of the side bar accumulation in the old channel, should be removed. As well, a weir field to protect the eroding bank along the residential properties is recommended, with a set-back berm to redirect any overbank flows back into the channel. Adding fill to the yard, and raising the house onto a higher foundation, should be considered by those residence owners where flood damage occurred. A preliminary conceptual

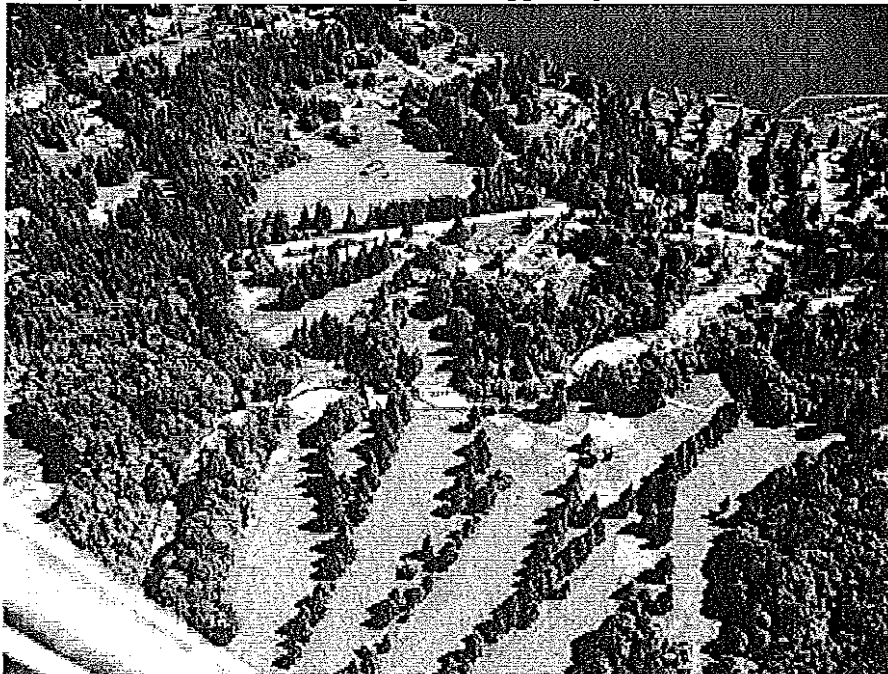
The north golf bridge abutment has a high probability of failure within a few years, unless some protective work is done. Loss of use of this bridge is a property damage, not a public safety, issue. However, if the abutment fails, and even one end of the bridge falls into the stream, blocking or diverting flow, it could create downstream consequences which do create a risk to public safety. If the abutment fails and the bridge obstructs flow, there is a moderate likelihood that the channel could avulse and move to the west from the golf course bridge down, which would increase flood risks to the homes between the golf course and the highway bridge, including the residences which flooded this last year, and to the highway. Although uncertain, this should probably be considered a high risk location.

Photo 2b: Golf course on Sutton Creek, golf course bridge just left of center, flood damaged residences and trailer park to upper right.

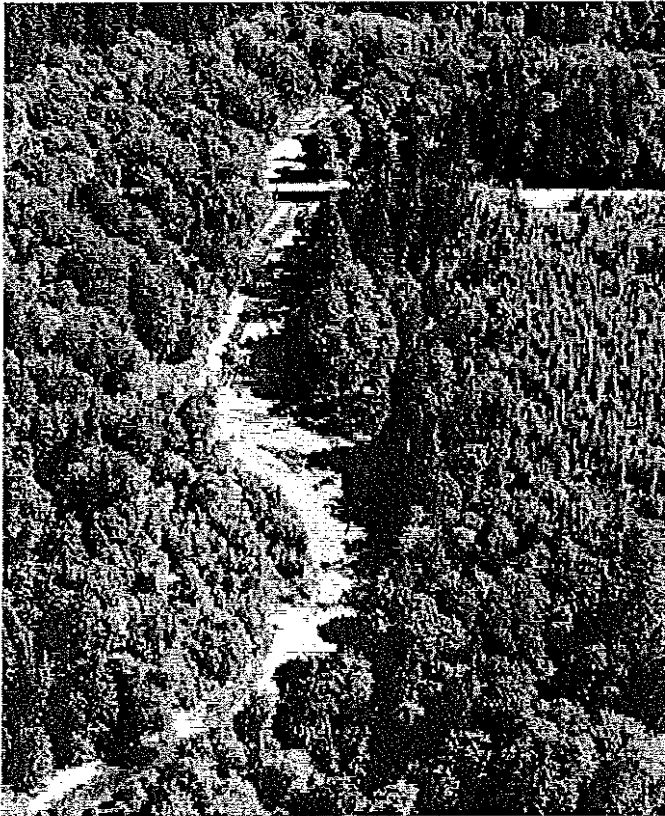
Photo 2c

The high gravel bars and large amount of LWD upstream of the logging bridge, especially where ponding occurred due to bridge opening blockage by LWD, but also in the kilometer upstream, create at least a low probability that a blockage could again occur. However, the consequences are relatively high, from loss of that bridge, to outburst flows again increasing the flows, and flood damage experienced, downstream to the lake, so risk could be described as at least moderate.

Looking downstream, at the large accumulation of bedload and LWD in the 250 m upstream of the logging bridge, where ponding occurred. Ecological Reserve is in the upper photo, downstream of the bridge.

3. To reduce the likelihood of the logging bridge opening again being obstructed by LWD, and to prevent the large accumulations of LWD and bedload in the 200 meters upstream of the bridge from moving into the populated reach in the next few high flows, it is recommended that the gravel accumulations for around 200 m upstream of the logging bridge be removed, and the LWD relocated to locations favorable to slowing bank erosion. A photo of this location is in appendix 2.

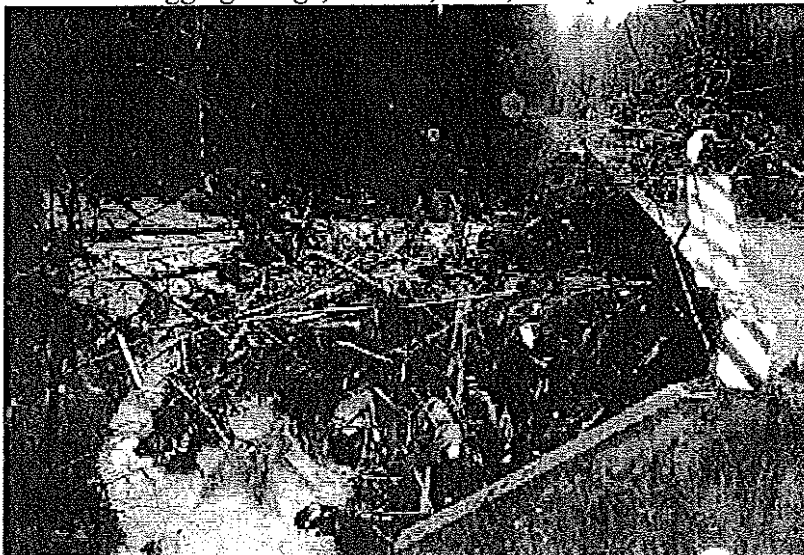
LWD accumulated and obstructed flow through the opening of the logging bridge above the golf course, constraining flow enough that water ponded to approximately 6 m depth, high enough to flow over the logging road. A large deposit of bedload settled out in the over 200 m of channel which was ponded upstream of the logging bridge, with LWD. Approximately 5 m of the fill behind one concrete bridge abutment failed, which increased flow capacity enough to release the ponded waters. It is unknown what the exact mechanism of the release of the ponded waters was, or how rapidly they were released, but even if gradual it would have added a component of outburst or dam break flow to the flows which entered the populated lowest reach of the Sutton.

Photo 2d: Logging bridge, Nov 15, 2006, after ponding release

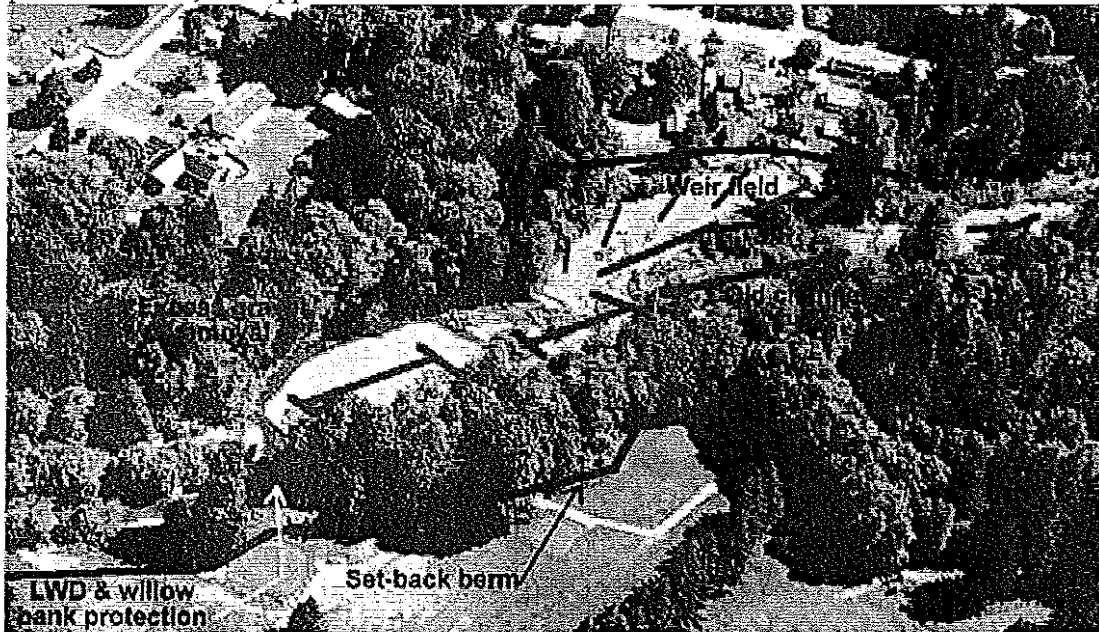
Photo 1. by residences flooded. Gravel removals, with weir field and LWD bank protection sites, and approximate locations where set-back berms would be beneficial

- design of weirs, with locations of needed gravel removals, has been sketched onto the air photo of this site attached as in Appendix 3.
2. To reduce the probability of failure of the left (NW) golf bridge abutment, a weir field, as bank protection for the upstream bank and the abutment, and to lengthen the radius of curvature and shift the thalweg out from the eroding bank, is recommended. In conjunction with the weir field, gravel relocation to reduce the point bar on the opposite side of the stream, which is pushing flow into the eroding bank, is recommended. A preliminary conceptual design of weirs, with locations of needed gravel removals, has been sketched onto the air photo of this site attached in Appendix 3.

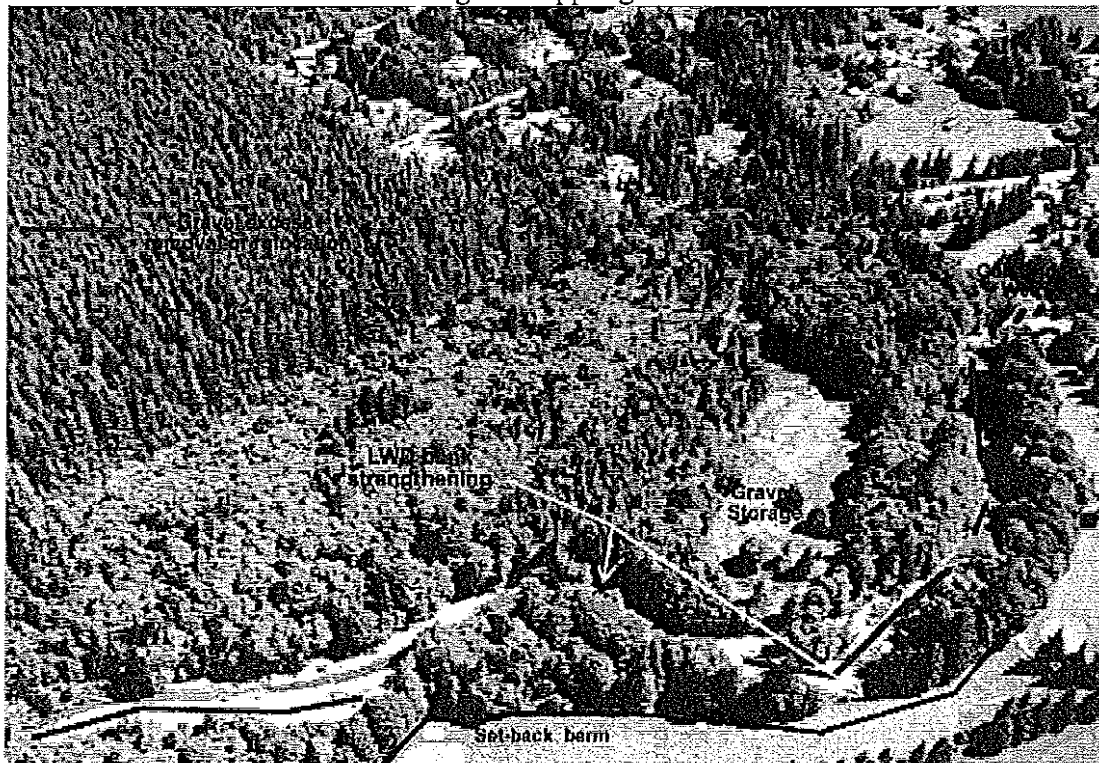
Photo 2. Recommended works through the upper golf course

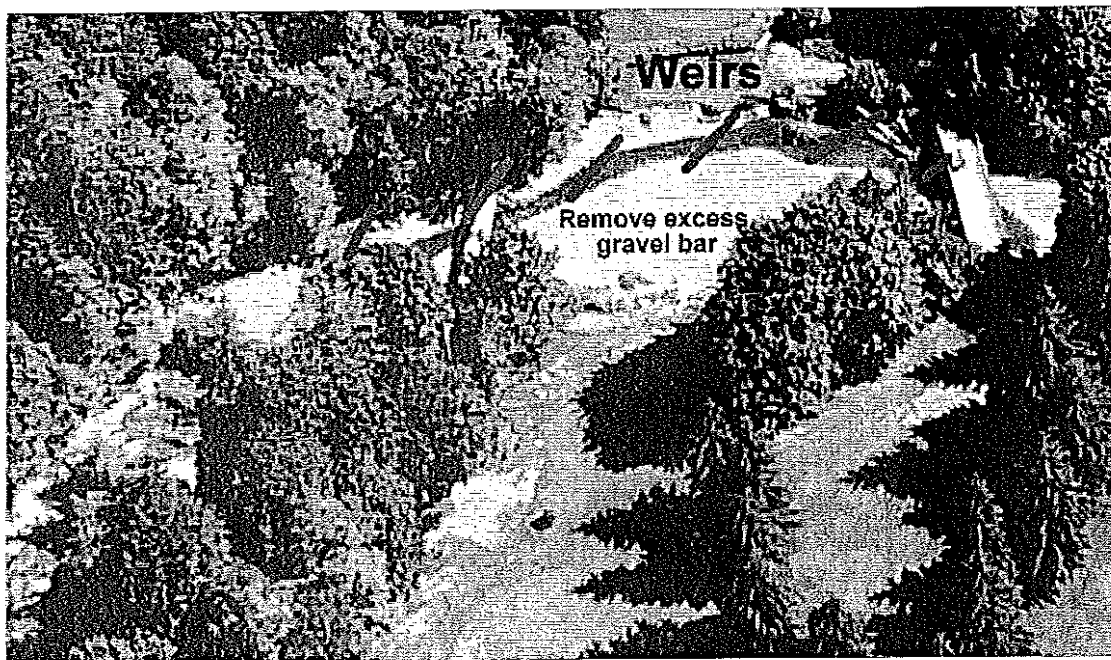
Photo 3.

Preliminary conceptual design for weir field bank protection upstream of the erosion threatened golf bridge abutment. Some fill and revegetation of the bank between weirs is required. It is recommended LWD and clumps of willows from bar removals, with larger excavated bar material, be utilized as fill.

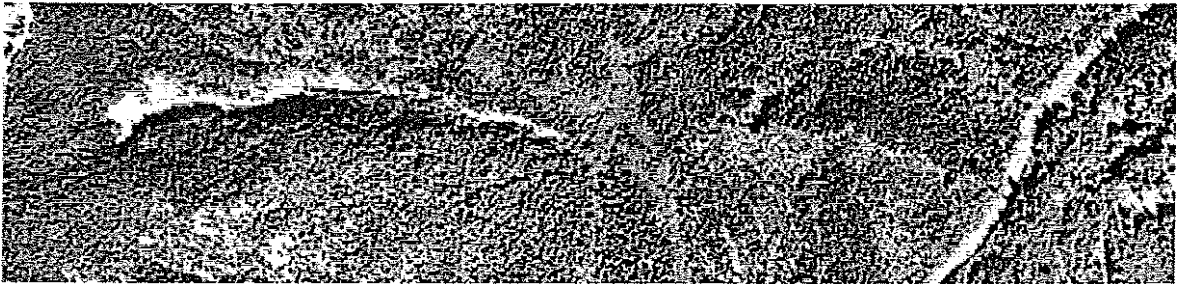
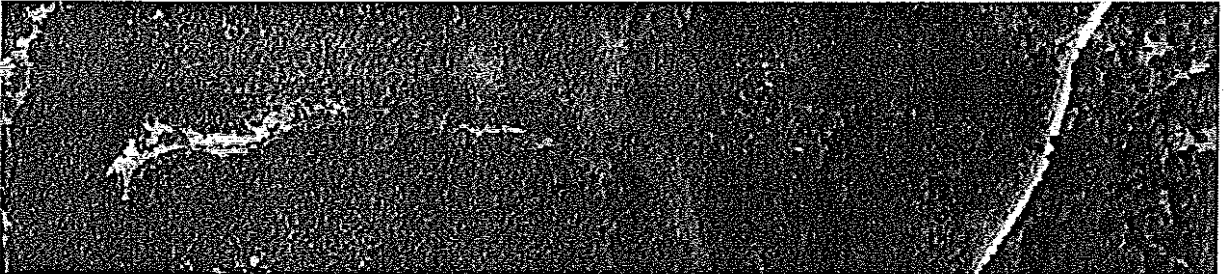
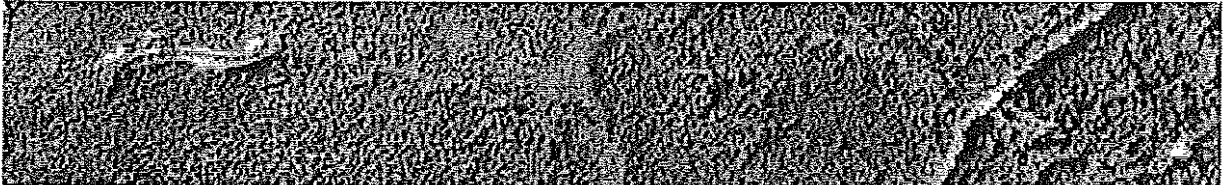
Tributary N1.5: Note erosion on left partially revegetated by 1984

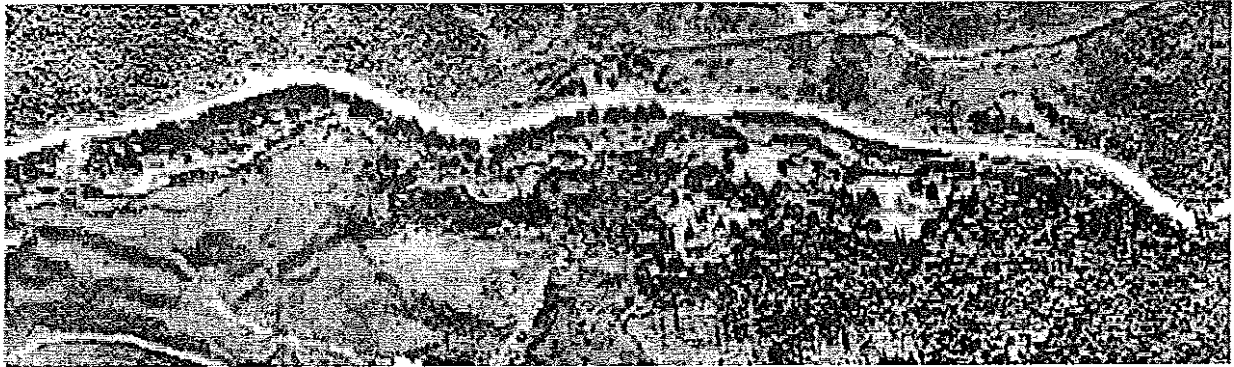
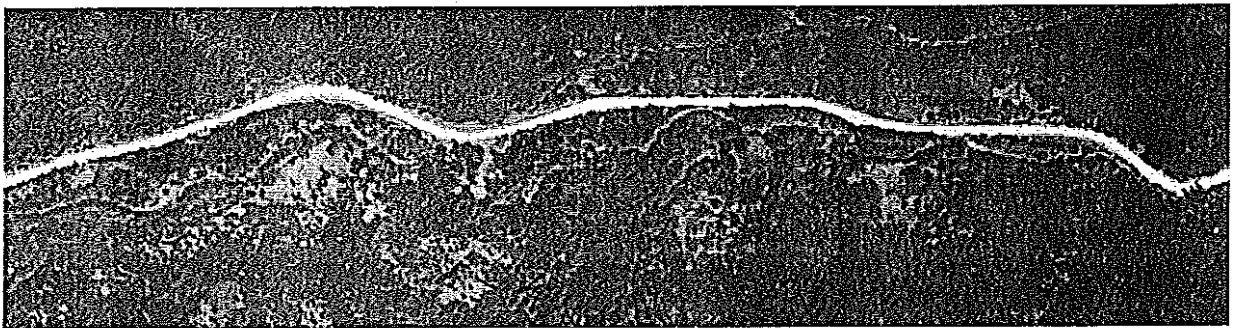
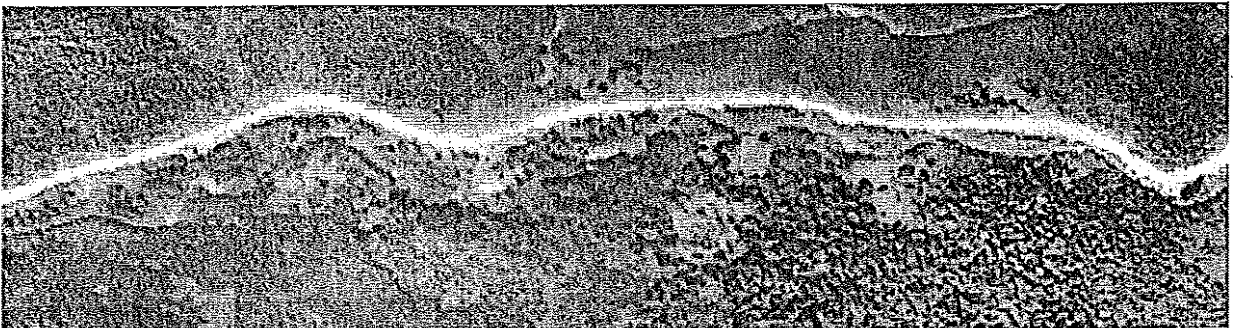
*Sutton main channel, Reach 3: Tributary S1 enters from bottom at far right.
Slide activity from Gordon River road at center left and far left?*

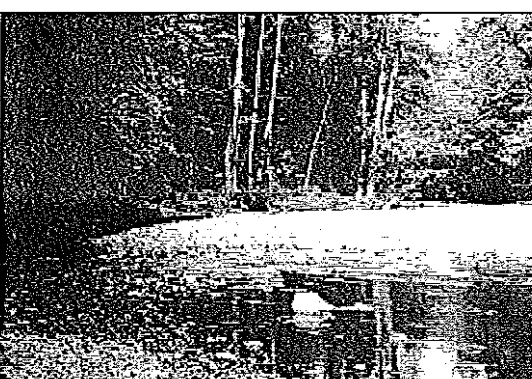
5. Sutton Cr, GRRoad km ~5.5, downstream of canyon	6. Old debris flow run-out, bottom of tributary S2

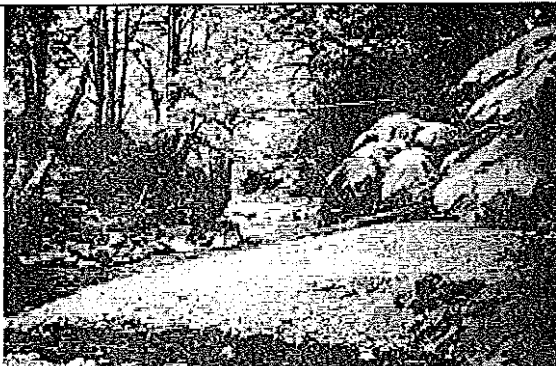
<p>7. Fan on tributary S2 by Sutton confluence</p>	<p>8. Sutton Cr upstream of tributary S1- note lack of bank height</p>

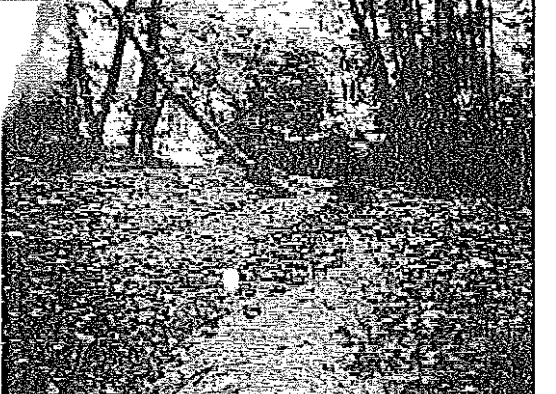
<p>11. Tributary N2 above road Stored sediment easily accessed</p>	<p>12. Sutton Cr downstream of S2</p>

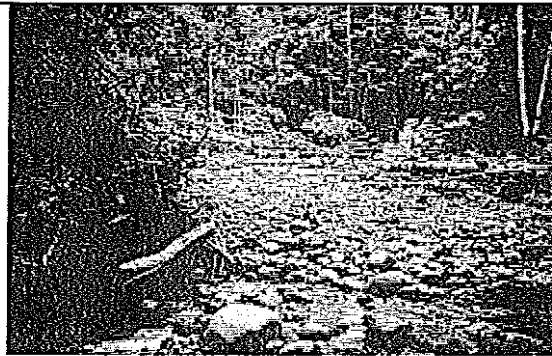
13. Large sediment wedge in Sutton Creek just upstream of S2

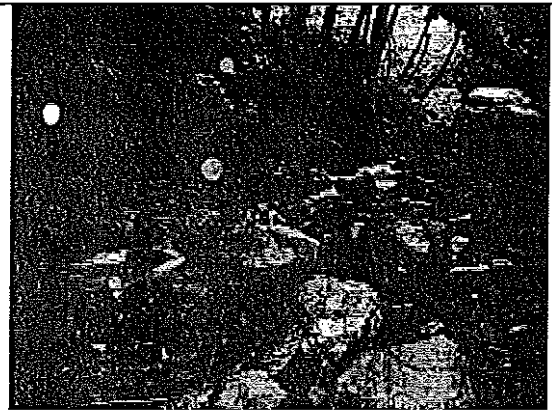
Tributary N4 appears to have very recently had a landside enter the channel a kilometer above the Sutton mainstem, resulting in a debris torrent running the length of the tributary to Sutton Creek, and down the mainstem. Photos of this tributary, and the mainstem below and above the Sutton confluence are given in appendix 6, the sediment source survey. Numerous areas of bank erosion of high steep banks, and at least one longer slide, are noted in the kilometer of Sutton downstream of tributary N4.

14. Tributary N4 downstream of km 11 bridge

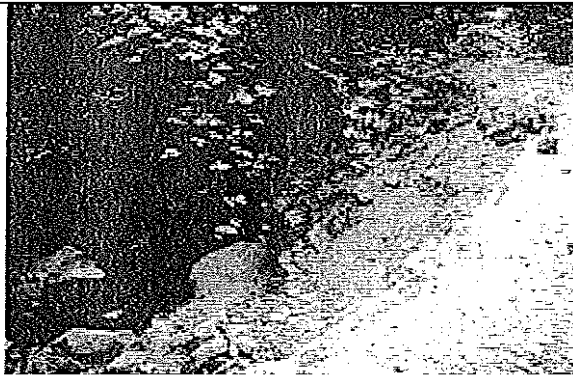
1. Failing shoulder of Gordon River rd just downstream of tributary S1.

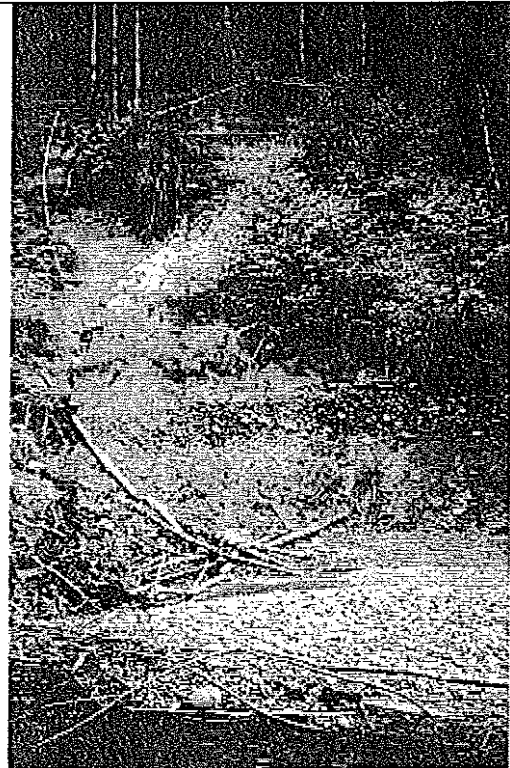
2. Tall eroding south bank of Sutton Cr at approx km 6.8

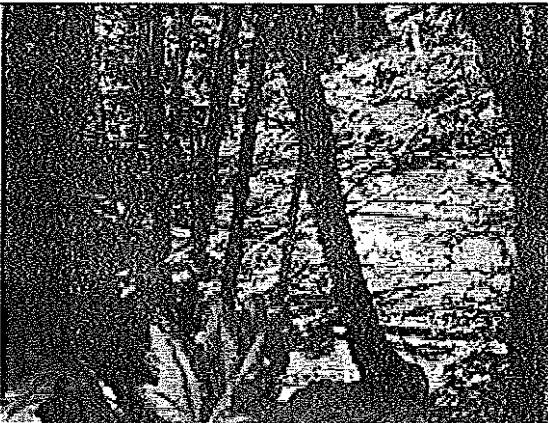
3. Eroding south bank of Sutton Creek Upstream of road marker km 7, widening bed

The above two photos' extensive bedload and LWD deposits may be settlement of some of the debris from the debris torrent in tributary N4 and resulting bank erosion on the Sutton channel below N4.

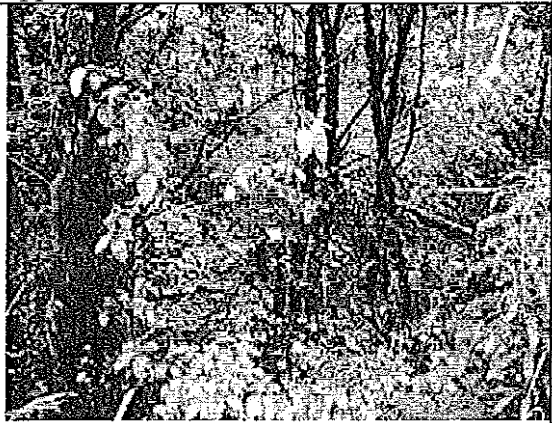
4. Slide or high bank erosion into south side of Sutton Cr near road marker km 8.

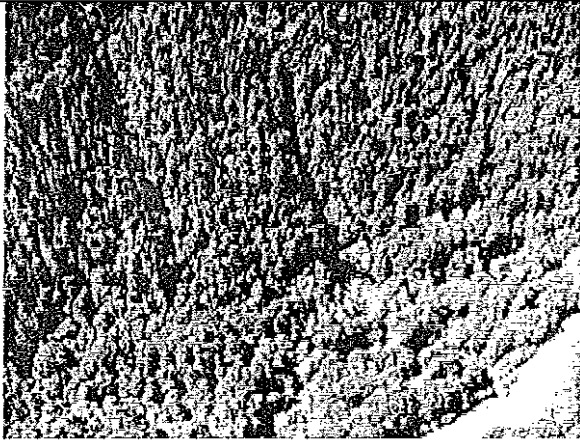
<p>5. Debris slide into Sutton Cr and historic slide tracks downstream of tributary N3</p>

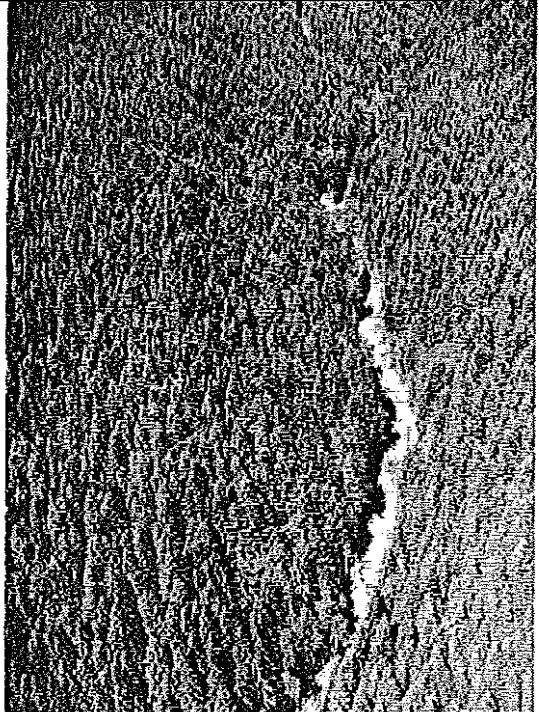
<p>7. Lower end of tributary N4 with debris torrent path to Sutton mainstem in upper photo.</p>	<p>6. Debris slide from hillside into upper end of debris torrented tributary N4</p>

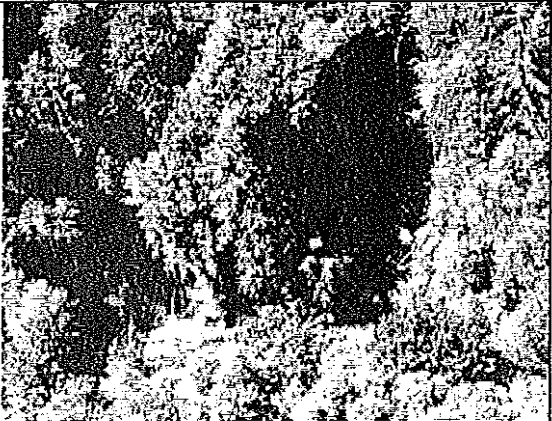
<p>8. Bank erosion from N4 debris torrent downstream of confluence with Sutton Creek</p>

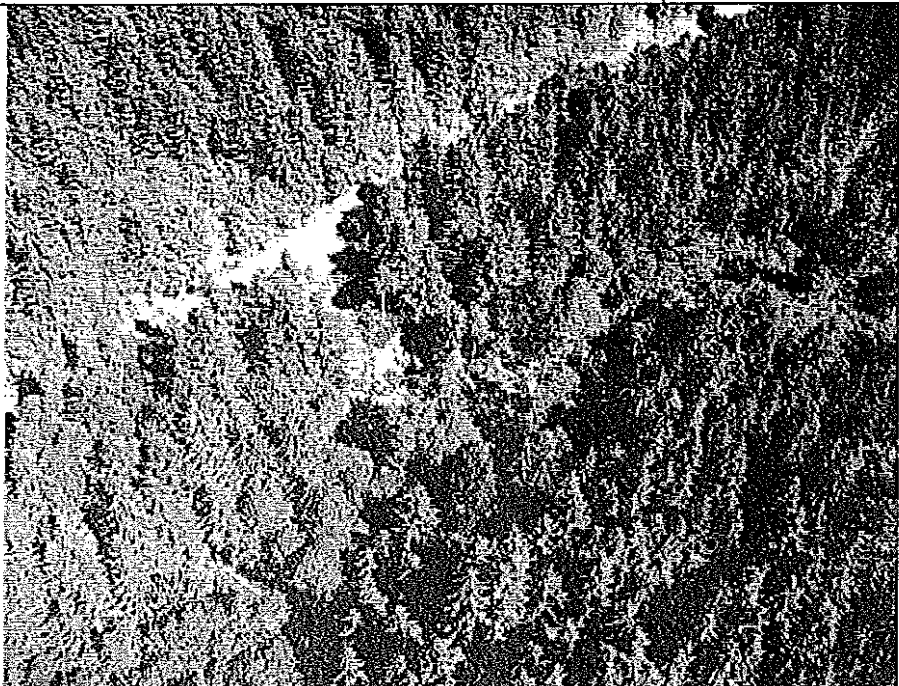
9. Mass wasting from side of Gordon R road at approx 11.3 km
