HAY & COMPANY CONSULTANTS INC.

MINISTRY OF PARKS
NIMPKISH RIVER
ECOLOGICAL RESERVE

Nimpkish River Ecological Reserve Erosion Protection Plan
(a draft copy)

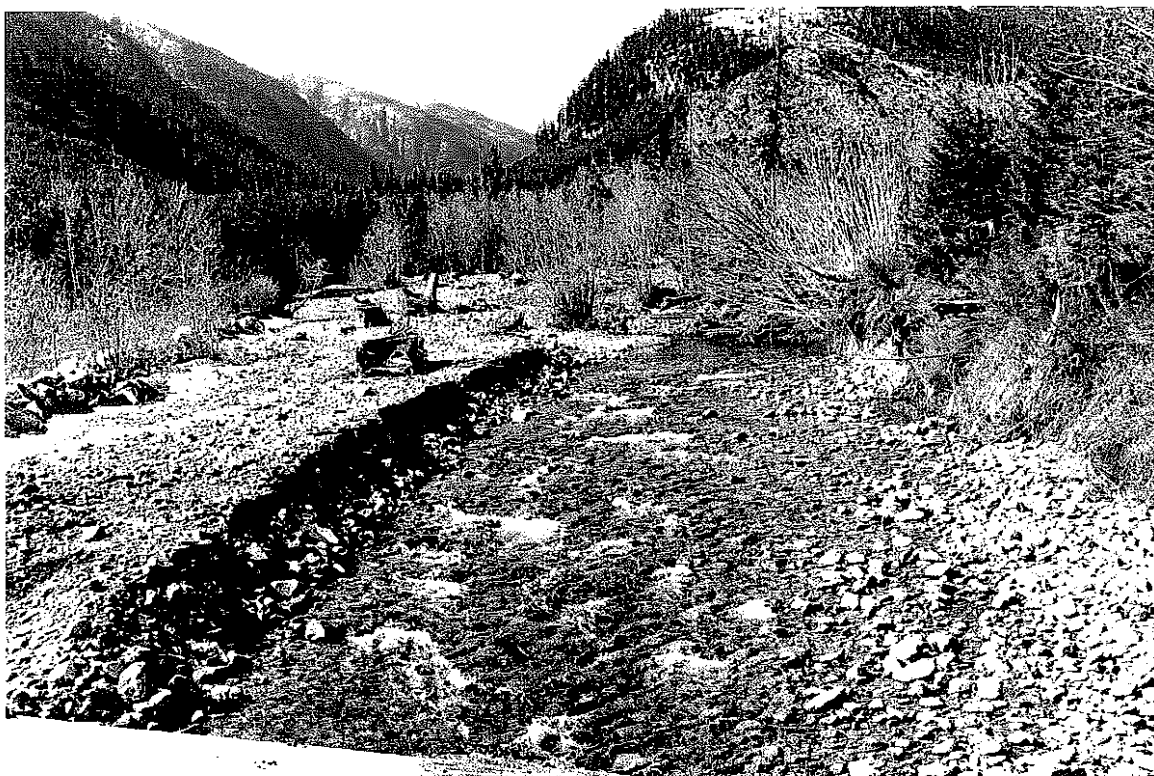
PHOTO 1: KIYU CREEK. SOUTH CHANNEL. LOOKING UPSTREAM

Since reverting back to the south channel, the stream has downcut into the bed by approximately 1 m, Photo 1. This downcutting has been accompanied by the meandering of the low flow channel with significant erosion of the right bank. These locally eroded sediments have been deposited on the fan at the mouth, extending the bar into the Nimpkish and resulting in the erosion along the north side of the island. Up to 30 m has been lost from the north east corner of the reserve since 1984.

Flow in the south channel of Kiyu Creek has not yet reached a state of equilibrium and further local erosion can be expected.

The outflow from Kiyu Creek will still present a problem in the long term as more sediments are deposited on the bar and the mouth migrates south towards the reserve. Shifting Kiyu Creek back to its northern channel and moving the gravel bar at its mouth against the island would enhance the stability of the north side of the reserve.

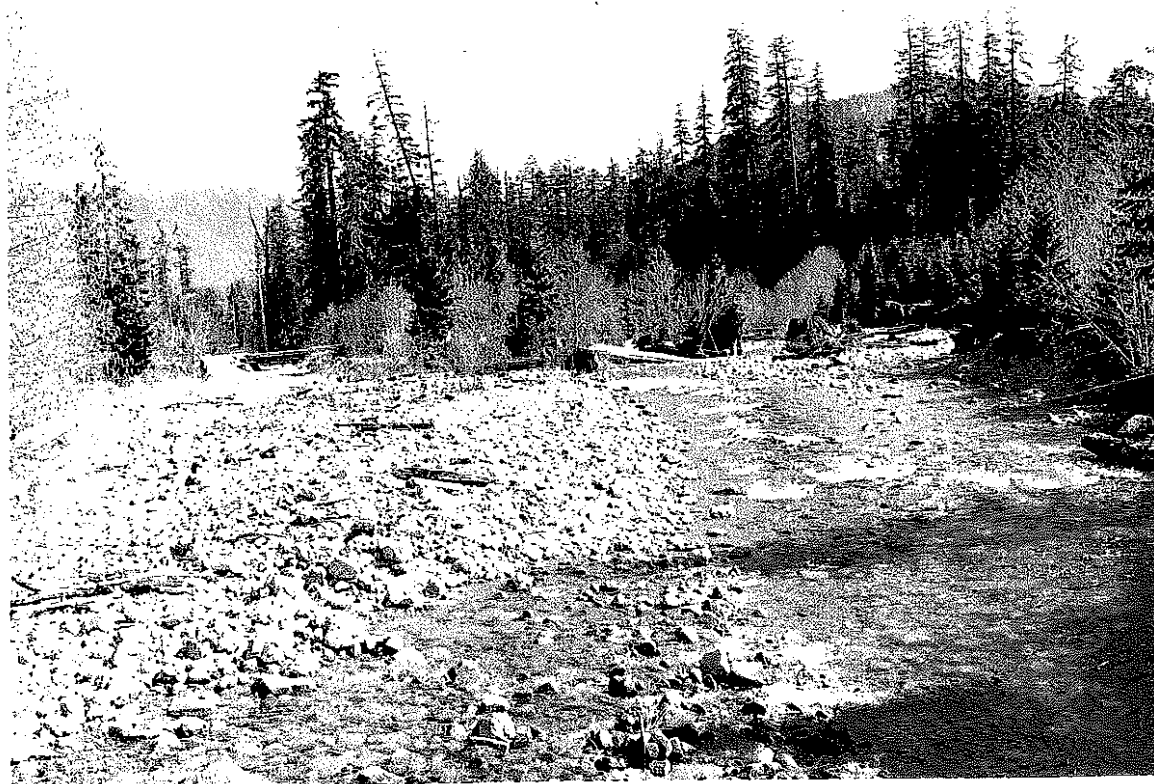
PHOTO 2: KIYU CREEK. LOOKING DOWNSTREAM AT THE CHANNEL SPLIT

A logging road crosses Kiyu Creek between the mouth and the split in the channels. The bridge over the northern dry channel was apparently shortened or replaced after the flow reverted back to the south channel. Evidence of this change can be seen in the field and the aperture under the northern bridge is now 50% of the opening under the southern bridge.

Left in its present state further erosion in Kiyu Creek south channel will enlarge the bar deposited at its mouth, squeezing the low flow channel of the Nimpkish River against the island and exacerbating the erosion.

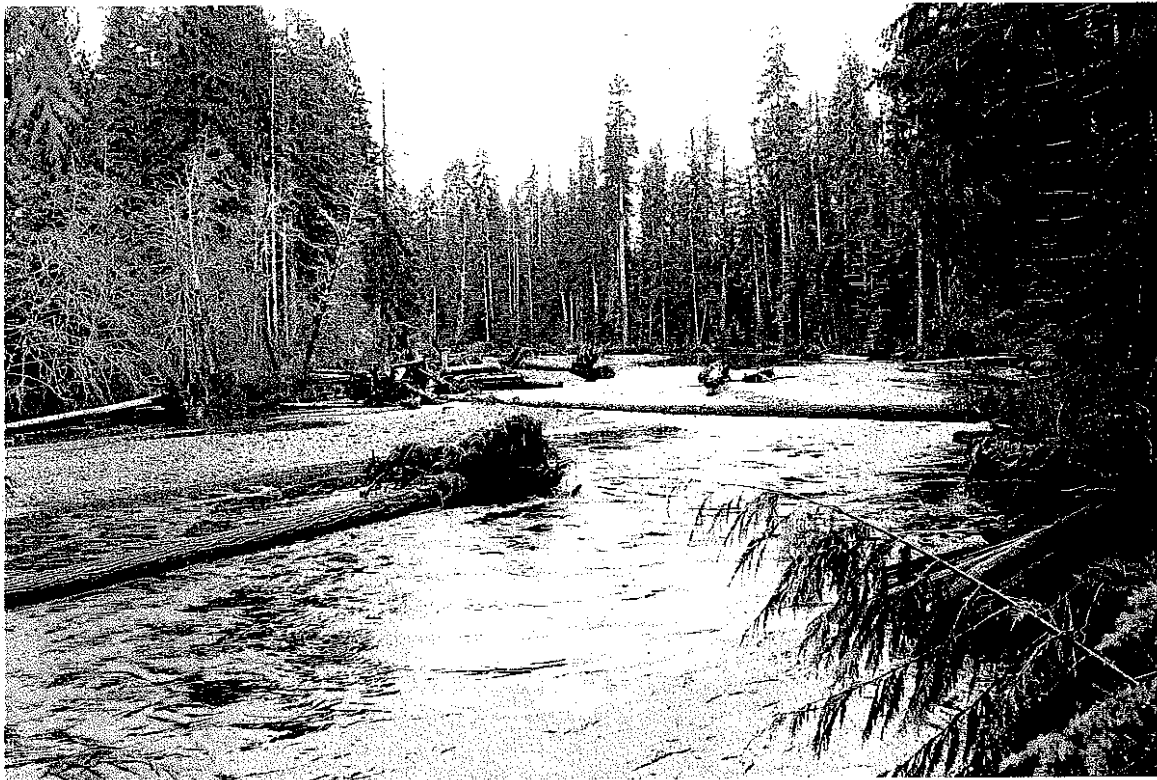
Extensive erosion is also evident upstream of the point bar on the outside of the large bend where the stream turns around the south west corner of the island. Considerable debris is evident in the channel and there is a potential for a log jam to develop, Photo 6. In its present state, gradual erosion along the concave section of the bank along the west side of the reserve will likely continue. However, it is not possible to predict future changes since obstructions such as log jams and sediment bars can lead to dramatic changes in the position of the low flow channel.

PHOTO 6• LOOKING UPSTREAM ALONG WEST SIDE OF ISLAND, NOTE LOG DEBRIS

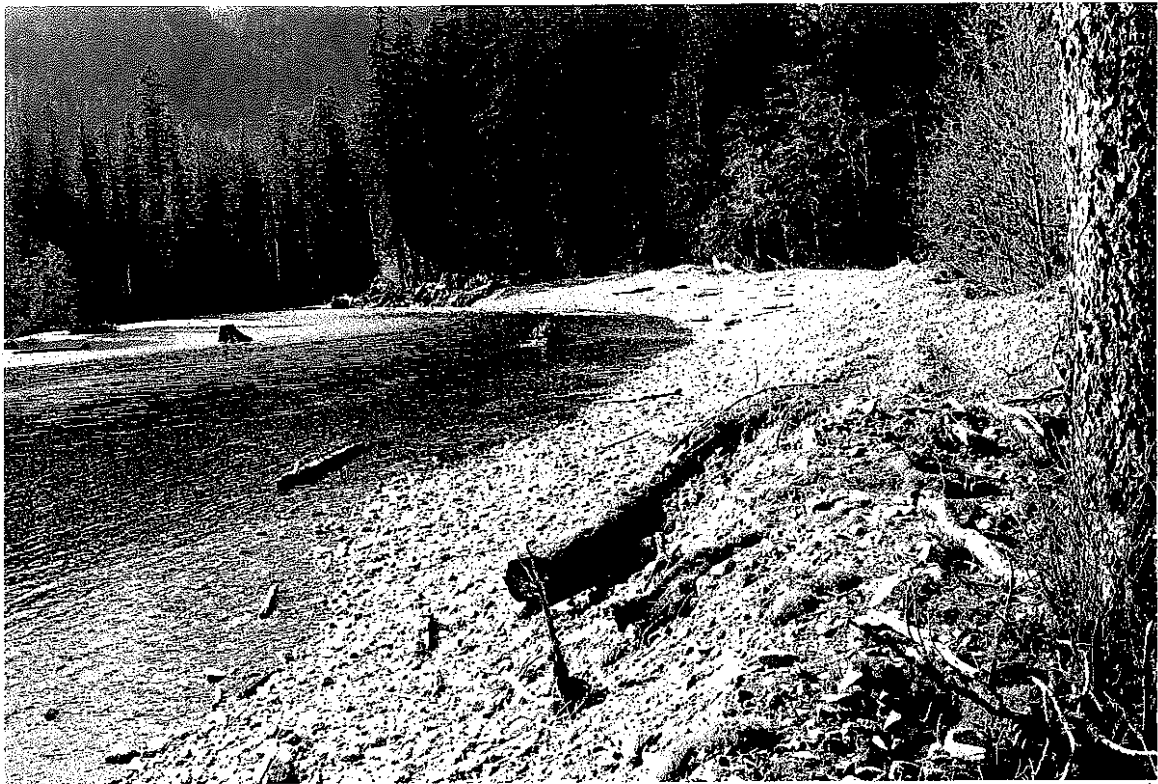
Although the berm has streamlined the channel along the south side of the island it has been constructed from light weight or transportable materials and cannot be expected to withstand overtopping or to have significant longevity. The gravel covering the downstream 50 m of the berm appears to have been washed out, leaving the mass of debris exposed.

There is no immediate threat to stability of the island's perimeter along the southeast corner and south side. In the event of the berm overtopping, the riprap will provide protection to the section of bank previously eroded.

PHOTO 7: NIMPKISH RIVER, LOOKING DOWNSTREAM ALONG 1987 BERM

The Southeast corner of the island is currently protected by the gravel and debris berm constructed by Water Management Branch in 1987. This berm is currently experiencing erosion and will at some future time be breached, allowing more water to flow down the main cutoff channel. Two options are available at this site:

- leave the berm as it is and address future breaching when it becomes critical, or
- reconstruct the berm now to create a stable structure.

Fixing up the berm would require installation of a riprapped overflow channel on the berm and some reinforcement of the berm with larger non-erodable material.

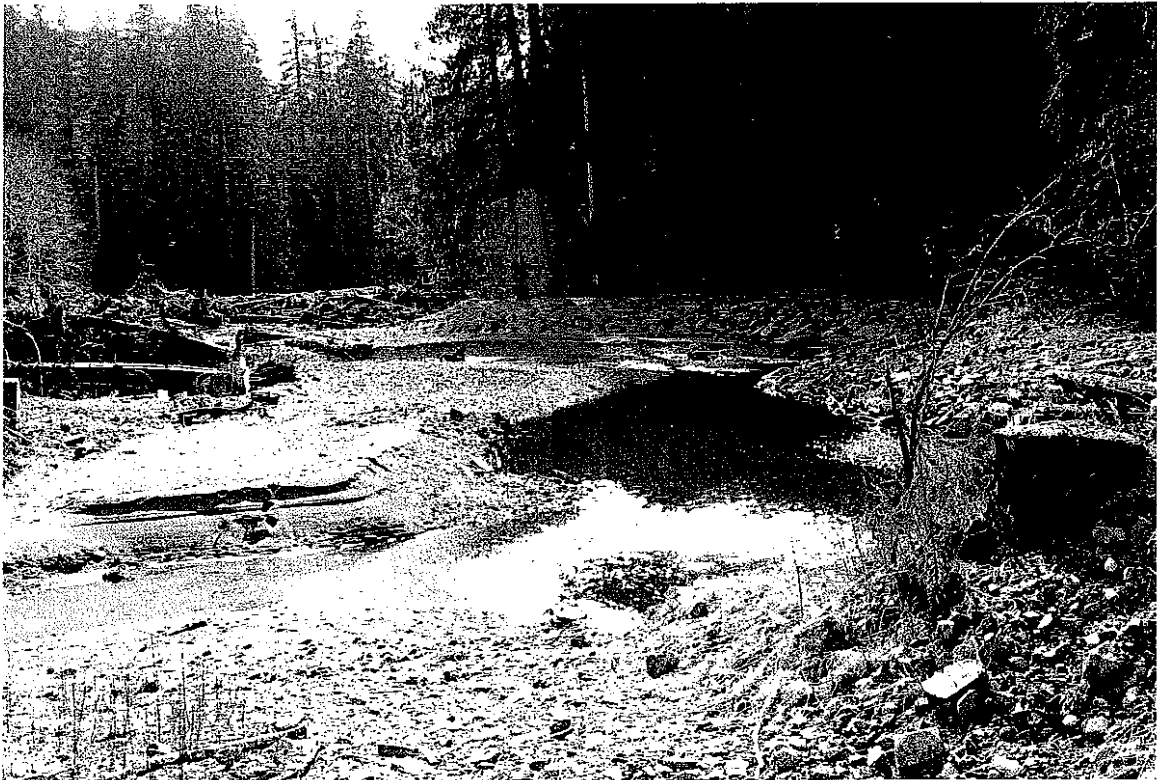
The east side of the island is formed by an active cutoff channel connecting the two legs of the U shape of the main channel. The cutoff channel is straight, approximately trapezoidal in shape with 2.5 m high banks. The conveyance capacity of the channel is approximately 1/2 to 1/3 of the capacity of the main channel around the other three sides of the island and should it see either a requisite or higher proportion of flow, gradual erosion along the east side can be expected. In the event of high flow severe local erosion would result, with trees being undercut and falling into the stream. The mouth of the cutoff channel is currently controlled by a large log jam resulting from the erosion of the northeast tip of the island opposite Kiyu Creek.

PHOTO 8: MAIN CUTOFF CHANNEL, LOOKING SOUTH ACROSS RIPRAP AND 1987 BERM

The main cutoff channel on the east side of the reserve has experienced erosion although the flow of water through this channel has been restricted by the berm constructed by WMB. If this channel is to be considered as providing overflow flood relief to the main Nimpkish channel in the future, bank protection should be considered along its entire length. As previously discussed, the bank protection could consist of either riprap or spur groynes. Unfortunately, the main cutoff channel is not wide enough to excavate gravel from the river bed and fill against the eroding bank, and the protective measures would be left exposed.
